Waterproofing an Underground Parking Garage in Chelsea

Waterproofing an Underground Parking Garage Without Disturbing the Garden Courtyard Above

Dayton Towers

EXTERIOR FAÇADE RESTORATION - ROOF REPLACEMENT - EXTERIOR TERRACE RESTORATION

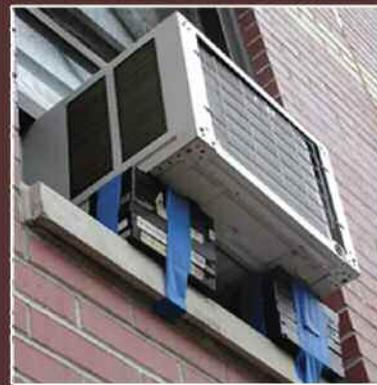
How NOT to install a window A/C.

- The air conditioner should have enough capacity to sufficiently cool the room and have a dedicated outlet with the proper amount of electrical current.
- The window and window frame in which the unit is mounted should be secure and in good condition.
- The air conditioner should be braced from underneath with metal brackets, mounting rails, or similar supports, or firmly fastened from inside with supporting angles. The metal brackets and angles should be attached to the exterior of the building and be strong enough to support the size and weight of the unit.
- Do not support the A/C unit with loose objects, such as bricks, wooden blocks, plywood, etc. We've even seen phone books and videocassette tapes wedged between the air conditioner and the window sill (although the digital era has

- If the position of the air conditioner needs to be adjusted with shims, they should be independently secured to prevent shifting caused by vibration, wind, or ice.
- Do not put items such as flower pots, satellite dishes, bird feeders, etc. on top of the A/C unit.
- The air conditioner should remain in place when the window is opened, or secured so that the window cannot be opened accidentally. It’s OK to tilt the unit for drainage if it’s not at a steep angle.
- An air conditioner should not be installed in a window that opens on to a fire escape.

An improperly secured window-mounted air conditioner is considered an unsafe item in a Local Law 11/98 façade inspection. To ensure compliance, Rand recommends that management establish building-wide installation guidelines for all residents to follow.

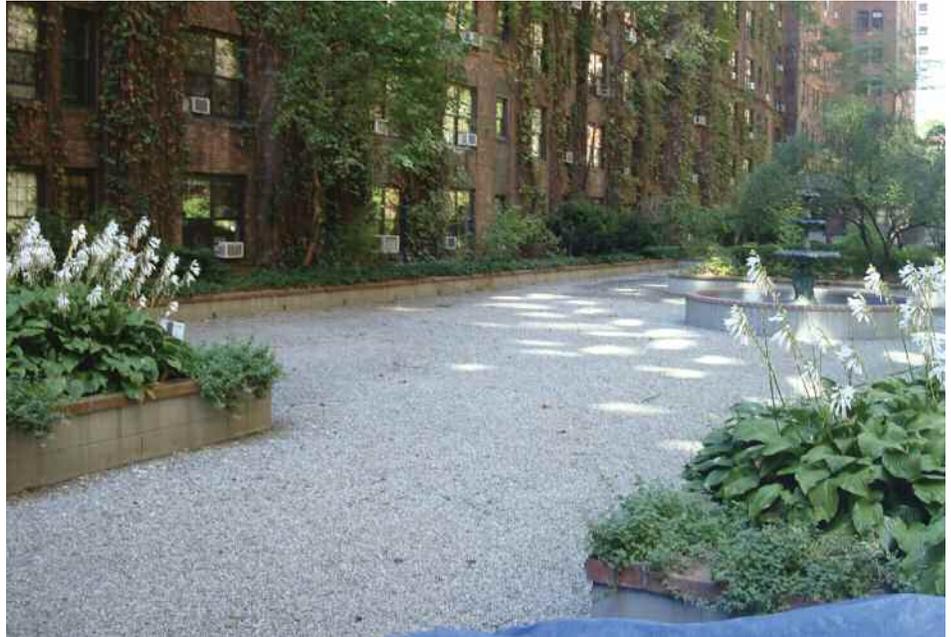
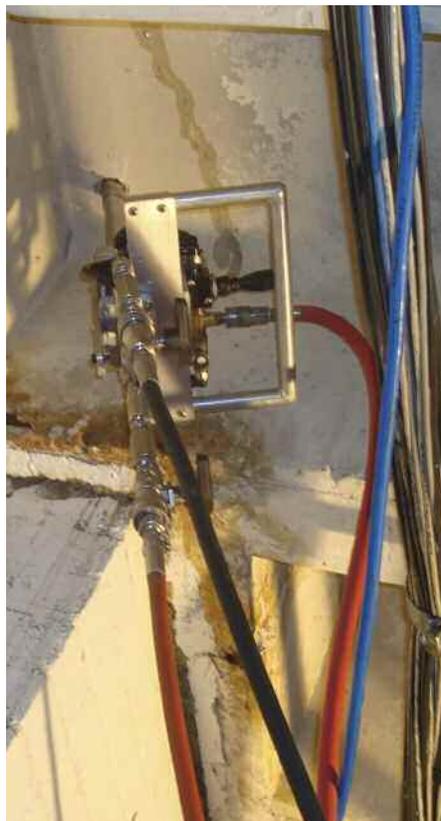
The CGI waterproofing system (below) is applied at the concrete walls of the underground parking garage of London Terrace, a 1930's residential building in Chelsea.

CGI performs “Concrete Gel Injection” by drilling and injecting through the negative (interior side), a two-component hydrophilic resin system that chemically reacts to form a flexible water sealing gel. The gel is non-toxic, odor free, and environmentally friendly. The gel will remain within the concrete structural slab for the life of the structure. By implementing its technology from the interior side, costly and disruptive exterior excavations are eliminated. Because the **Aqua Loc Resin LV** and the additives are close to the viscosity of water, these fluids can migrate into the tiniest of cracks, fissures and water pockets within the depth of the concrete. In addition, the fluids will also travel full depth to the membrane above to form a gel, where the membrane has been compromised.

garage. These locations are believed to be the major contributors to the water leakage. The rainwater enters at these openings, and then migrates through the compromised membrane and the cracks below. If these locations are sealed up, then most of the cracks should not exhibit water leakage. Should some cracks continue to leak, then injection waterproofing at the particular locations will be performed. CGI is presently coordinating with the parking garage management to perform the injection waterproofing, with minimal inconvenience to the car owners and parking attendants.

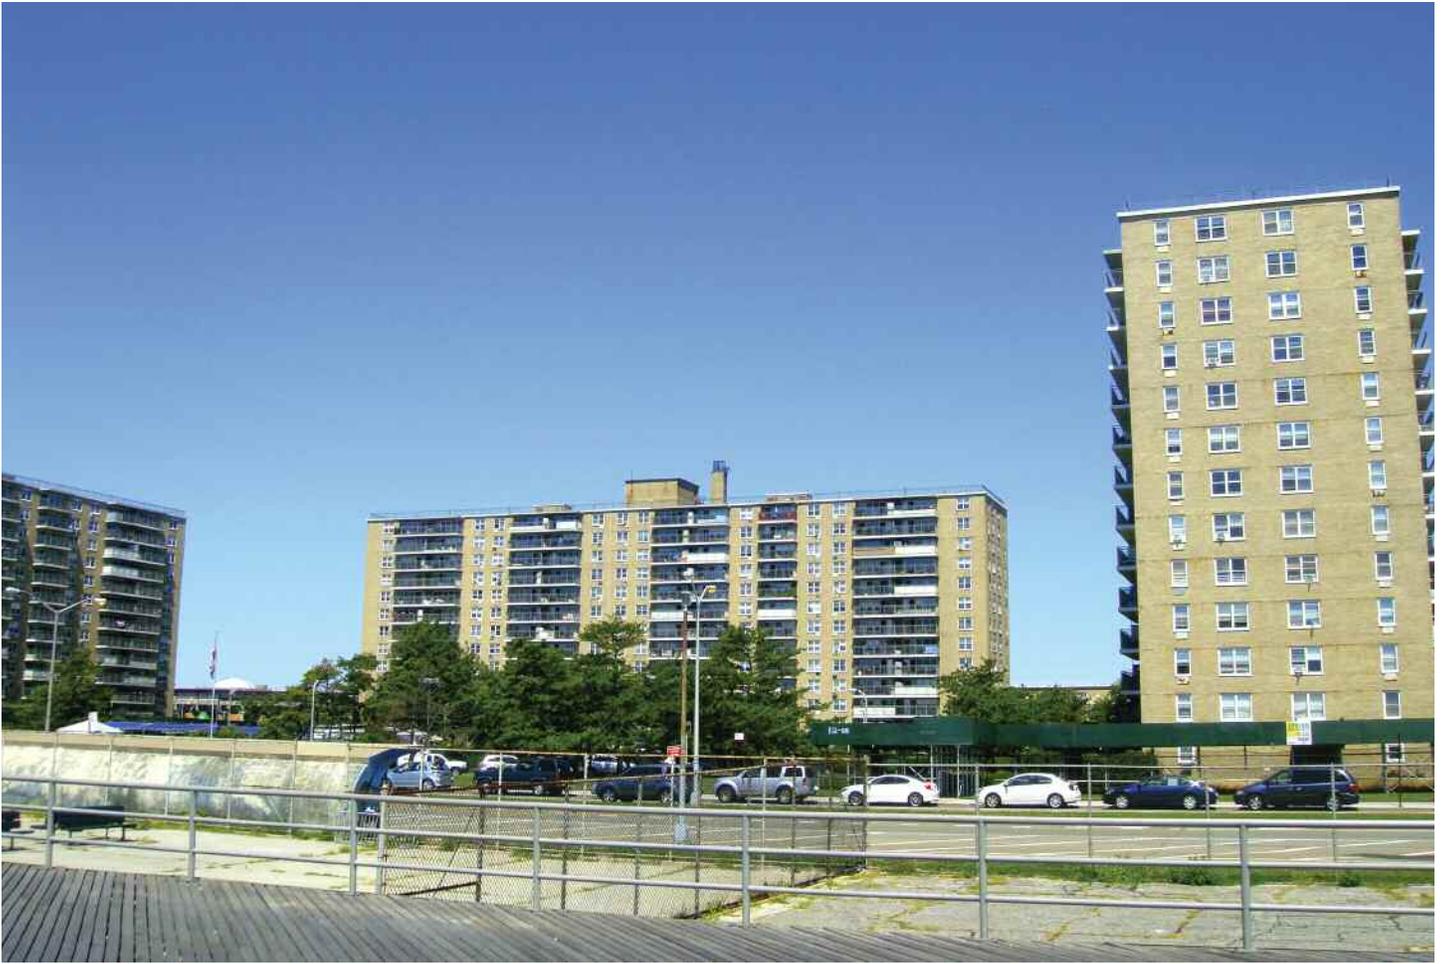
102-00, 103-00, 105-00 Shore Front Parkway, Rockaway Beach, NY

The project at Dayton Towers encompasses concrete, masonry, metal, balcony and roofing work. A fully insured, licensed asbestos abatement company was hired to perform abatement under balcony carpets, at the bulkhead roof and along shelf angles. The remainder of the 2.5 year project will include roof removal and replacement, utilizing a Siplast roof system; balcony patching and traffic coating using BASF products, relieving angle and lintel replacement, brick and expansion joint replacement, and removal and replacement of all balcony railings and dividers.

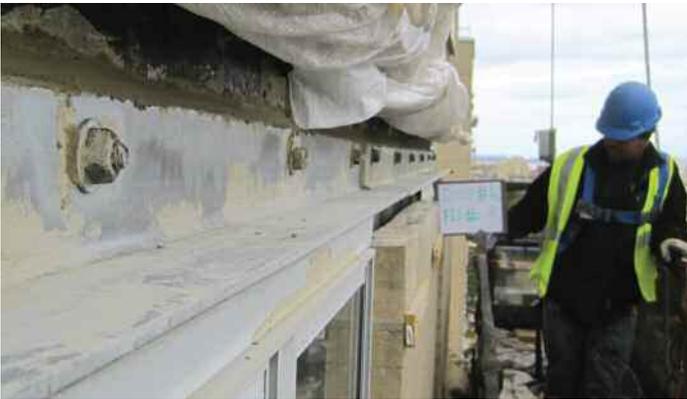
Sample of shelf angle replacement at 7400 Shore Front Parkway

Remove, replace or repair relieving angles and lintels. Perform face brick and expansion joint replacement to match existing. Chimney corner replacement. Replace glass block windows and provide and install new precast concrete chimney caps with flashing at bulkhead and chimneys.

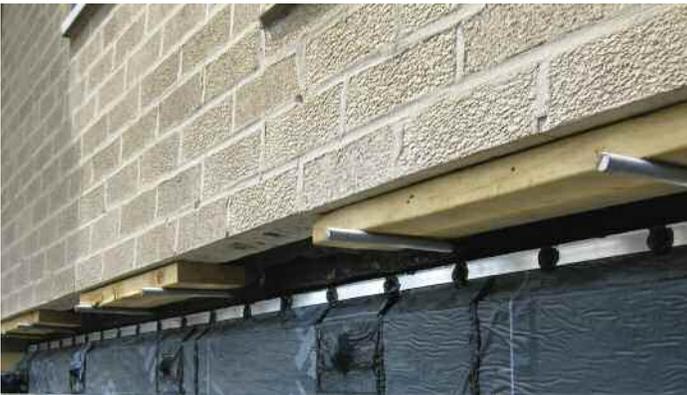
Sample waterproofing at 8000 Shore Front Parkway

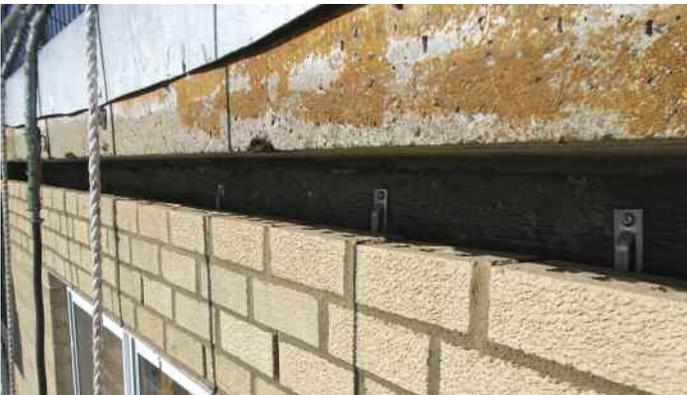
Sample brickwork at 8000 Shore Front Parkway
